**Flood Control Project Maintenance
Levee Inspections**
LMA District Cover Sheet
Spring 2017 Levee Inspection Results

Reclamation District No. 1001 Nicolaus

Unit Cover Sheet

Spring 2017 Levee Inspection Results

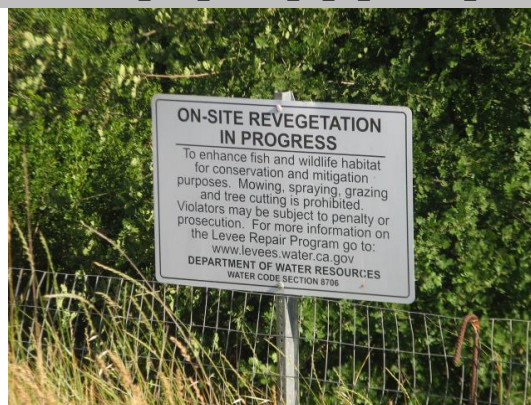
Photo 1 of 1 : SP_2017_RD1001_37_25_20170316_00017.jpg

LM Start	11.59	Rating **	A/W	Issue No.	25
LM End	11.80	Issue Type +	Ob	Location *	WS
Category	Earthen Levee			GPS Latitude/Longitude	
				Start	End
Item	Vegetation			38.951302 °	38.950960 °
				-121.556872 °	-121.560717 °
DWR ID	DWR_RD1001_03_s_2013_25				
Comment Code					
V8 : Environmental Requirements.					
Inspector Comment

Revegetation site in progress. Spring 2013

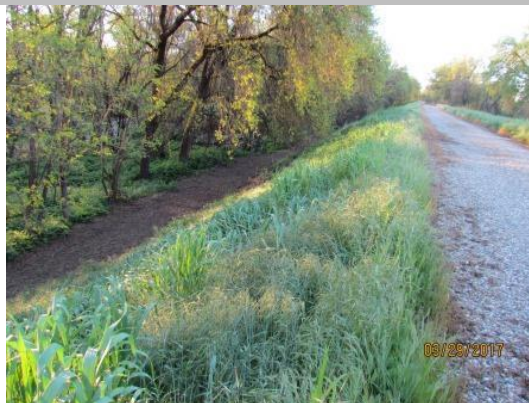
Photo 1 of 1 : SP_2017_RD1001_38_35_20170403_00066.jpg

LM Start	0.01	Rating **	M	Issue No.	35
LM End	2.50	Issue Type +	Ma	Location *	LS
Category	Earthen Levee			GPS Latitude/Longitude	
				Start	End
Item	Vegetation			38.940892 °	38.906724 °
				-121.567674 °	-121.576035 °
DWR ID	DWR_RD1001_04_s_2017_35				
Comment Code					
V1 : Control annual grass and weeds on the levee slopes and easements.					
Inspector Comment					
Maintain annual vegetation, Spring 2017.

View looking downstream of annual vegetation, Spring 2017.

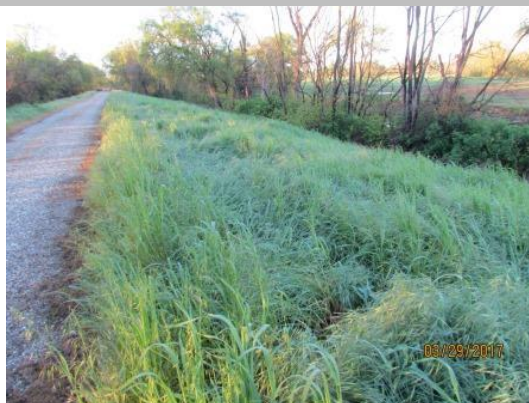
Photo 1 of 1 : SP_2017_RD1001_38_38_20170403_00067.jpg

LM Start	0.01	Rating **	M	Issue No.	38
LM End	13.28	Issue Type +	Ma	Location *	WS
Category	Earthen Levee			GPS Latitude/Longitude	
				Start	End
Item	Vegetation			38.940884 °	38.781238 °
				-121.567680 °	-121.605477 °
DWR ID	DWR_RD1001_04_s_2017_38				
Comment Code					
V1 : Control annual grass and weeds on the levee slopes and easements.					
Inspector Comment					
Maintain annual vegetation, Spring 2017.

View looking downstream of annual vegetation, Spring 2017.

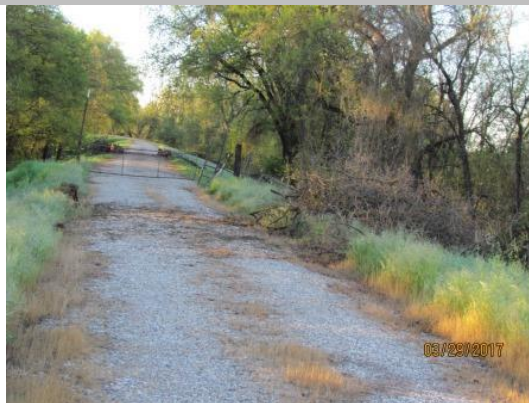
Photo 1 of 1 : SP_2017_RD1001_38_3_20170403_00068.jpg

LM Start	0.14	Rating **	M	Issue No.	3
LM End	0.14	Issue Type +	Ma	Location *	WS
Category	Earthen Levee			GPS Latitude/Longitude	
				Start	End
Item	Encroachments			38.939029 °	38.939029 °
				-121.567771 °	-121.567771 °
DWR ID	DWR_RD1001_04_s_2017_3				
Comment Code					
PR : Prunings					
Inspector Comment					
Remove pruning's from hinge point, Spring 2017.

View looking downstream of pruning's on hinge point, Spring 2017.

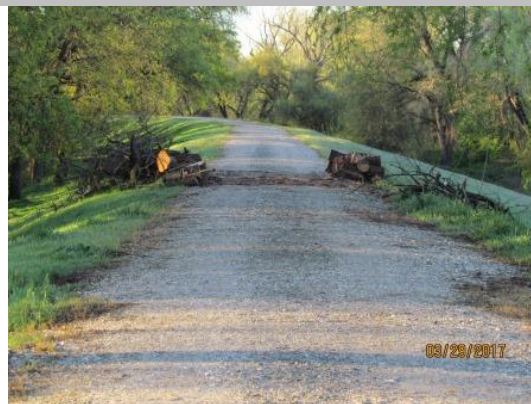
Photo 1 of 1 : SP_2017_RD1001_38_42_20170403_00069.jpg

LM Start	0.20	Rating **	M	Issue No.	42
LM End	0.20	Issue Type +	Ma	Location *	CR
Category	Earthen Levee			GPS Latitude/Longitude	
				Start	End
Item	Encroachments			38.938233 °	38.938233 °
				-121.567731 °	-121.567731 °
DWR ID	DWR_RD1001_04_s_2017_42				
Comment Code					
PR : Prunings					
Inspector Comment					
Remove pruning's from fallen tree from both sides of hinge points, Spring 2017.

view looking downstream of pruning's from fallen tree on both sides of hinge points, Spring 2017.

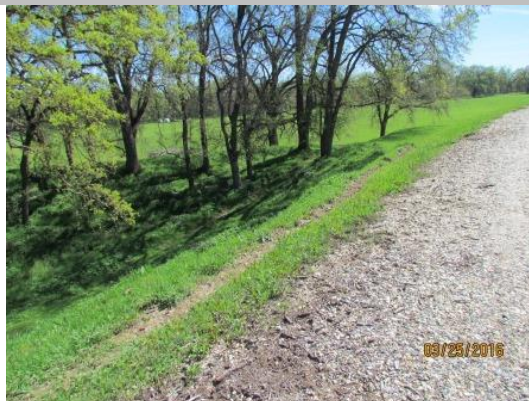
Photo 1 of 3 : SP_2017_RD1001_38_64_20170316_00037.jpg

Livestock trail cut into landside slope. Spring 2016.

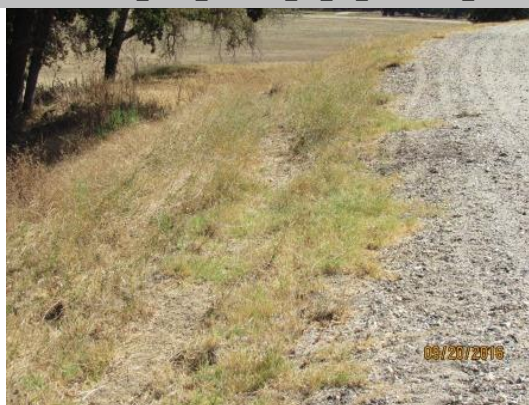
Photo 2 of 3 : SP_2017_RD1001_38_64_20170316_00038.jpg

View of animal trail cut into the landside levee slope. Fall 2016.

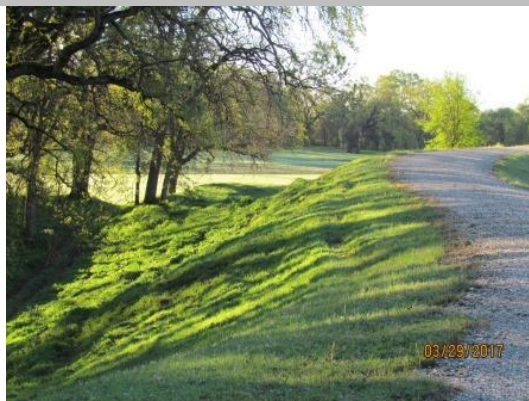
Photo 3 of 3 : SP_2017_RD1001_38_64_20170403_00070.jpg

LM Start	0.37	Rating **	A/W	Issue No.	64
LM End	0.37	Issue Type +	Ma	Location *	LS
Category	Earthen Levee			GPS Latitude/Longitude	
				Start	End
Item	Animal Control			38.935903 °	38.935903 °
				-121.567250 °	-121.567250 °
DWR ID	DWR_RD1001_04_s_2016_64				
Comment Code					
A2 : Repair the levee slope damaged by livestock and prevent large animal access.					
Inspector Comment					
Animal trail is not being used and shows no sign of erosion or sloughing. Spring 2017.

View looking downstream of animal trail that is not being used and shows no sign of erosion or sloughing. Spring 2017.

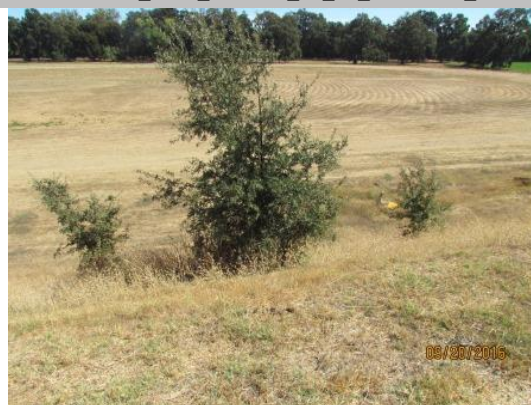
Photo 1 of 1 : SP_2017_RD1001_38_59_20170316_00033.jpg

LM Start	0.49	Rating **	M	Issue No.	59
LM End	0.49	Issue Type +	Ma	Location *	LS
Category	Earthen Levee			GPS Latitude/Longitude	
				Start	End
Item	Trim / Thin Trees			38.934139 °	38.934139 °
				-121.567025 °	-121.567025 °
DWR ID	DWR_RD1001_04_f_2016_59				
Comment Code					
T2 : Thin trees to allow visibility of the ground and room to flood fight.					
Inspector Comment					
Trees 4" in diameter or less at chest height should be removed.

View of three trees with diameters less than 4". Fall 2016.

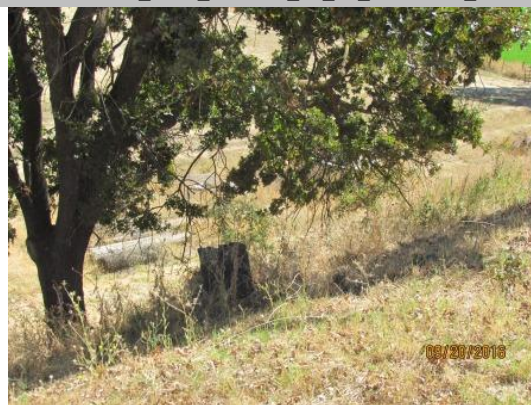
Photo 1 of 1 : SP_2017_RD1001_38_21_20170316_00013.jpg

LM Start	0.51	Rating **	N	Issue No.	21
LM End	0.51	Issue Type +	Ma	Location *	LS
Category	Earthen Levee			GPS Latitude/Longitude	
				Start	End
Item	Trim / Thin Trees			38.933796 °	38.933796 °
				-121.567047 °	-121.567047 °
DWR ID	DWR_RD1001_04_f_2015_21				
Comment Code					
T5 : Tree stumps.					
Inspector Comment					
Remove stump from the landside levee slope.

View of a stump in the landside levee slope. Fall 2016.

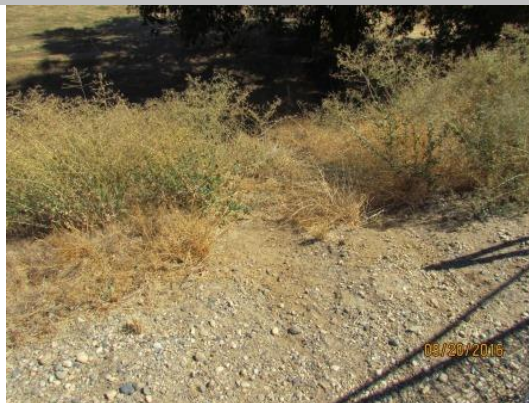
Photo 1 of 1 : SP_2017_RD1001_38_68_20170316_00040.jpg

LM Start	0.55	Rating **	M	Issue No.	68
LM End	0.55	Issue Type +	Ma	Location *	LS
Category	Earthen Levee			GPS Latitude/Longitude	
				Start	End
Item	Slope Stability			38.933299 °	38.933299 °
				-121.567069 °	-121.567069 °
DWR ID	DWR_RD1001_04_s_2016_68				
Comment Code					
S3 : Repair the levee slope damaged by vehicle traffic and prevent access where possible.					
Inspector Comment

View of ruts caused by vehicle on the landside levee slope. Fall 2016.

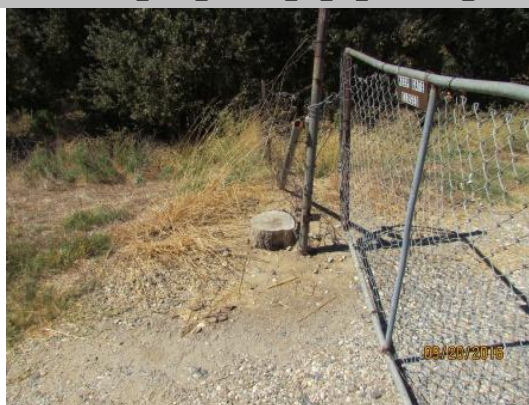
Photo 1 of 1 : SP_2017_RD1001_38_60_20170316_00034.jpg

LM Start	0.55	Rating **	N	Issue No.	60
LM End	0.55	Issue Type +	Ma	Location *	WS
Category	Earthen Levee			GPS Latitude/Longitude	
				Start	End
Item	Trim / Thin Trees			38.933229 °	38.933229 °
				-121.567097 °	-121.567097 °
DWR ID	DWR_RD1001_04_f_2016_60				
Comment Code					
T5 : Tree stumps.					
Inspector Comment

View of tree stump, waterside crown at gate. Fall 2016.

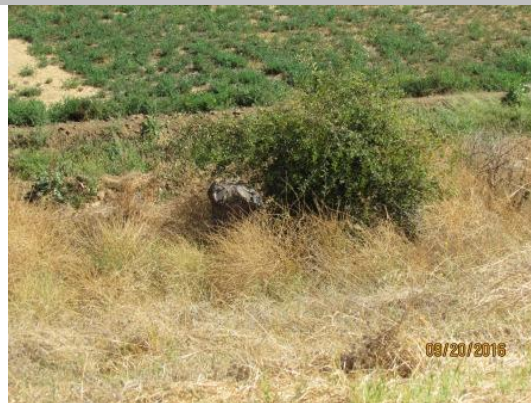
Photo 1 of 1 : SP_2017_RD1001_38_69_20170316_00041.jpg

LM Start	1.06	Rating **	N	Issue No.	69
LM End	1.06	Issue Type +	Ma	Location *	LS
Category	Earthen Levee			GPS Latitude/Longitude	
				Start	End
Item	Trim / Thin Trees			38.926128 °	38.926128 °
				-121.568241 °	-121.568241 °
DWR ID	DWR_RD1001_04_s_2016_69				
Comment Code					
T5 : Tree stumps.					
Inspector Comment

View of stump at landside levee toe. Fall 2016.

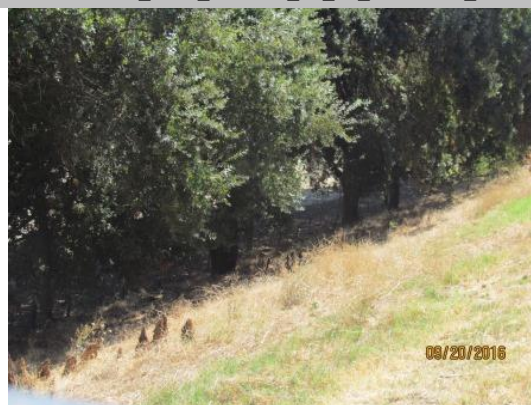
Photo 1 of 1 : SP_2017_RD1001_38_39_20170316_00024.jpg

LM Start	2.05	Rating **	A/W	Issue No.	39
LM End	2.05	Issue Type +	Ma	Location *	LS
Category	Earthen Levee			GPS Latitude/Longitude	
				Start	End
Item	Trim / Thin Trees			38.912664 °	38.912664 °
				-121.572928 °	-121.572928 °
DWR ID	DWR_RD1001_04_s_2015_39				
Comment Code					
T2 : Thin trees to allow visibility of the ground and room to flood fight.					
Inspector Comment

Tree limbs have been trimmed to allow visibility and access on the landside looking downstream. Fall 2016.

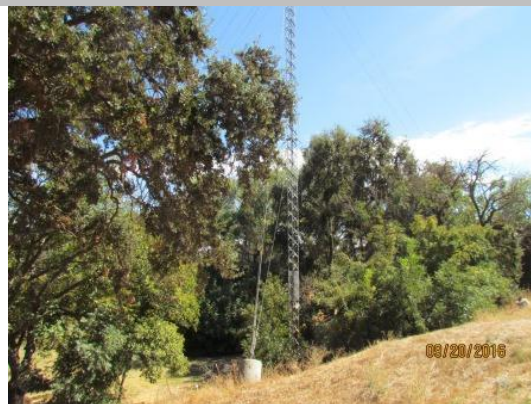
Photo 1 of 1 : SP_2017_RD1001_38_19_20170316_00011.jpg

LM Start	2.27	Rating **	M	Issue No.	19
LM End	2.27	Issue Type +	En	Location *	LS
Category	Earthen Levee			GPS Latitude/Longitude	
				Start	End
Item	Encroachments			38.909790 °	38.909790 °
				-121.574449 °	-121.574449 °
DWR ID	DWR_RD1001_04_s_2013_19				
Comment Code					
PO : Pole					
Inspector Comment

View of power pole and guy wire on the levee slope. Fall 2016.

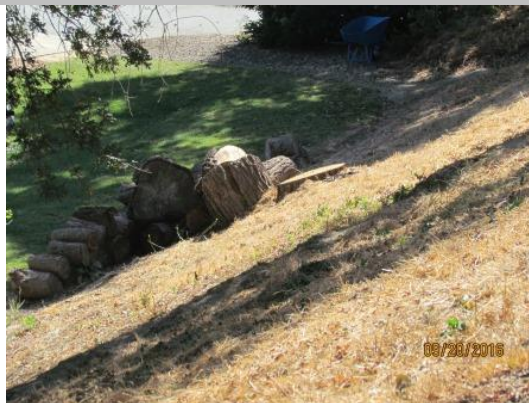
Photo 1 of 1 : SP_2017_RD1001_38_33_20170316_00021.jpg

LM Start	2.44	Rating **	M	Issue No.	33
LM End	2.44	Issue Type +	En	Location *	LS
Category	Earthen Levee			GPS Latitude/Longitude	
				Start	End
Item	Encroachments			38.907506 °	38.907506 °
				-121.575390 °	-121.575390 °
DWR ID	DWR_RD1001_04_f_2015_33				
Comment Code					
FW : Firewood					
Inspector Comment					
Remove firewood at levee toe.

View of firewood at the landside levee toe. Fall 2016.

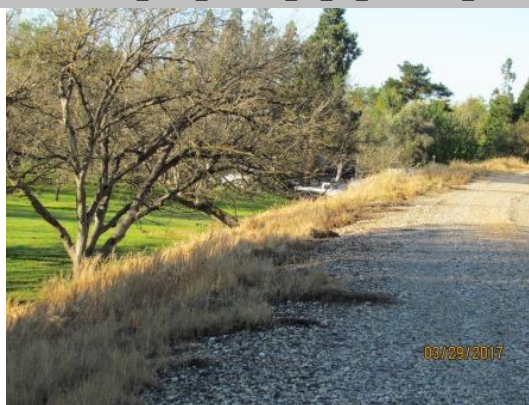
Photo 1 of 1 : SP_2017_RD1001_38_43_20170403_00071.jpg

LM Start	2.50	Rating **	M	Issue No.	43
LM End	2.68	Issue Type +	Ma	Location *	LS
Category	Earthen Levee			GPS Latitude/Longitude	
				Start	End
Item	Vegetation			38.906729 °	38.905096 °
				-121.576036 °	-121.578468 °
DWR ID	DWR_RD1001_04_s_2017_43				
Comment Code					
V1 : Control annual grass and weeds on the levee slopes and easements.					
Inspector Comment					
Sprayed annual grasses, Spring 2017.

View looking downstream of sprayed annual grasses, Spring 2017.

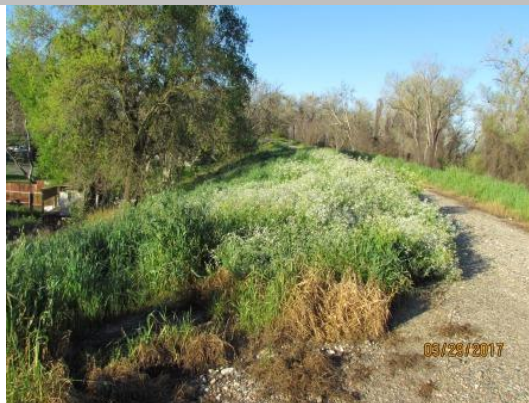
Photo 1 of 1 : SP_2017_RD1001_38_44_20170403_00073.jpg

LM Start	2.68	Rating **	U	Issue No.	44
LM End	13.28	Issue Type +	Ma	Location *	LS
Category	Earthen Levee			GPS Latitude/Longitude	
				Start	End
Item	Vegetation			38.905088 °	38.781238 °
				-121.578480 °	-121.605477 °
DWR ID	DWR_RD1001_04_s_2017_44				
Comment Code					
V1 : Control annual grass and weeds on the levee slopes and easements.					
Inspector Comment					
Maintain annual vegetation, Spring 2017.

View looking downstream of annual vegetation, Spring 2017.

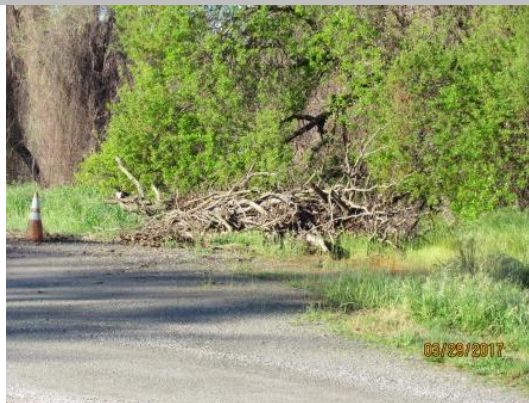
Photo 1 of 1 : SP_2017_RD1001_38_45_20170403_00072.jpg

LM Start	2.80	Rating **	M	Issue No.	45
LM End	2.80	Issue Type +	Ma	Location *	WS
Category	Earthen Levee			GPS Latitude/Longitude	
				Start	End
Item	Encroachments			38.903908 °	38.903908 °
				-121.580228 °	-121.580228 °
DWR ID	DWR_RD1001_04_s_2017_45				
Comment Code					
PR : Prunings					
Inspector Comment					
Remove pruning's on hinge point, Spring 2017.

View looking downstream of pruning's on hinge point, Spring 2017.

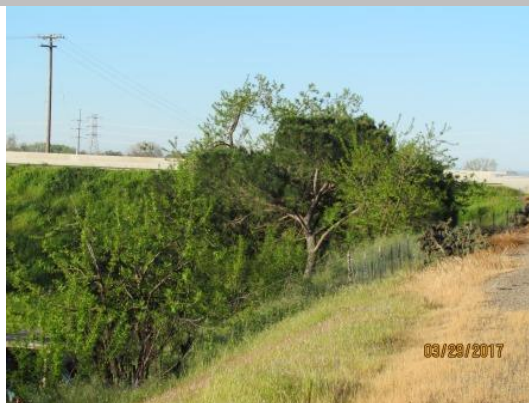
Photo 1 of 2 : SP_2017_RD1001_38_48_20170403_00075.jpg

LM Start	3.16	Rating **	M	Issue No.	48
LM End	3.19	Issue Type +	En	Location *	LS
Category	Earthen Levee			GPS Latitude/Longitude	
				Start	End
Item	Encroachments			38.899835 °	38.899499 °
				-121.583986 °	-121.584462 °
DWR ID	DWR_RD1001_04_s_2017_48				
Comment Code					
FE : Fence					
Inspector Comment					
Fence and landscaping has been placed by the land owner on levee slope and needs to be removed, Spring 2017

View looking downstream of fence and landscaping that has been placed by the land owner on levee slope and needs to be removed, Spring 2017.

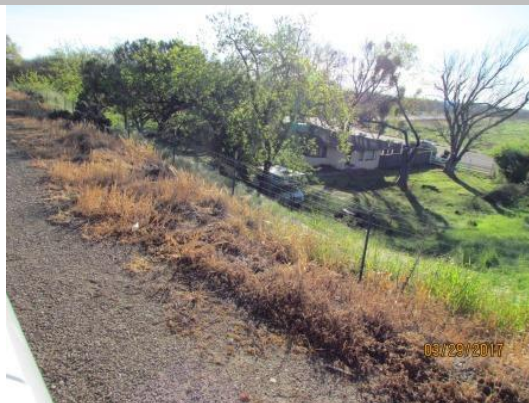
Photo 2 of 2 : SP_2017_RD1001_38_48_20170403_00077.jpg

LM Start	3.16	Rating **	M	Issue No.	48 (cont)	
LM End	3.19	Issue Type +	En	Location *	LS	
Category	Earthen Levee			GPS Latitude/Longitude		
				Start		End
Item	Encroachments			38.899835 °		38.899499 °
				-121.583986 °		-121.584462 °
DWR ID	DWR_RD1001_04_s_2017_48					
Comment Code						
FE : Fence						
Inspector Comment						
Fence and landscaping has been placed by the land owner on levee slope and needs to be removed, Spring 2017

View looking upstream of fence and landscaping that has been placed by the land owner on levee slope and needs to be removed, Spring 2017.

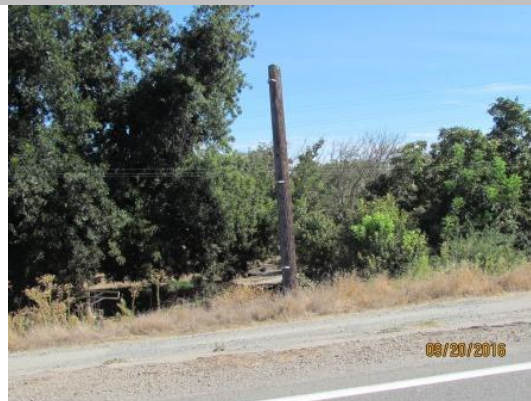
Photo 1 of 1 : SP_2017_RD1001_38_27_20170316_00016.jpg

LM Start	5.71	Rating **	M	Issue No.	27
LM End	5.71	Issue Type +	En	Location *	LS
Category	Earthen Levee			GPS Latitude/Longitude	
				Start	End
Item	Encroachments			38.874984 °	38.874984 °
				-121.614242 °	-121.614242 °
DWR ID	DWR_RD1001_04_s_2015_27				
Comment Code					
PO : Pole					
Inspector Comment

View of pole on landside, no lines connected to it. Fall 2016.

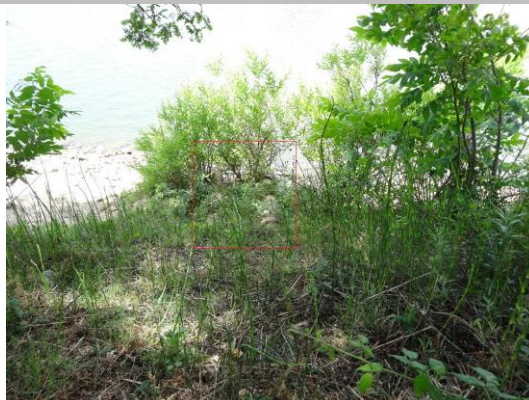
Photo 2 of 3 : UCIP_SP_2017_14604_24106.jpg

WS- inlet pipe on the river bank.

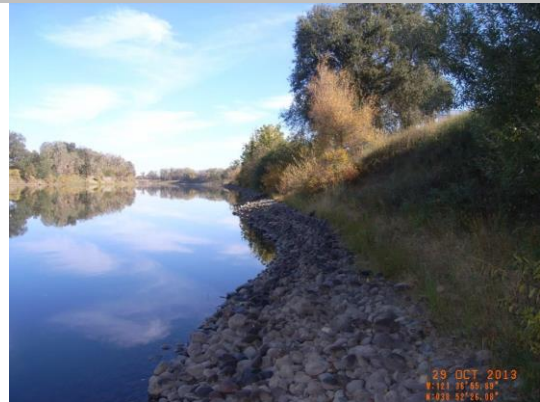
Photo 1 of 1 : SP_2017_RD1001_38_2_20170316_00002.jpg

LM Start	5.80	Rating **	M	Issue No.	2
LM End	5.93	Issue Type +	Ma	Location *	WS
Category	Supplemental			GPS Latitude/Longitude	
				Start	End
Item	2015 USACE Erosion Survey, DRAFT			38.874113 °	38.872373 °
				-121.615380 °	-121.616504 °
DWR ID	DWR_RD1001_04_s_2016_2				
Comment Code					
Inspector Comment					
2011 - Erosion pockets from tree popouts. Sections of the lower bank have slumped off. 2013 - Scallops from tree popouts no longer visible on site. Minor new erosion at the middle of the bank. 2015: Fresh erosion from human use. [2015 Site ID: FHR_6-6_L]

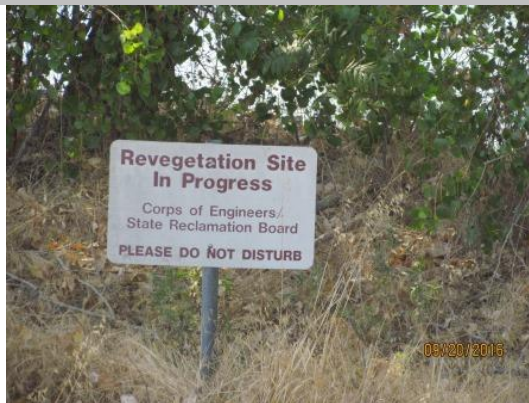
Photo 1 of 1 : SP_2017_RD1001_38_40_20170316_00025.jpg

LM Start	5.96	Rating **	A/W	Issue No.	40
LM End	5.96	Issue Type +	Ob	Location *	WS
Category	Earthen Levee			GPS Latitude/Longitude	
				Start	End
Item	Vegetation			38.871770 °	38.871770 °
				-121.616304 °	-121.616304 °
DWR ID	DWR_RD1001_04_s_2015_40				
Comment Code					
V8 : Environmental Requirements.					
Inspector Comment

Vegetation was introduced to this location.

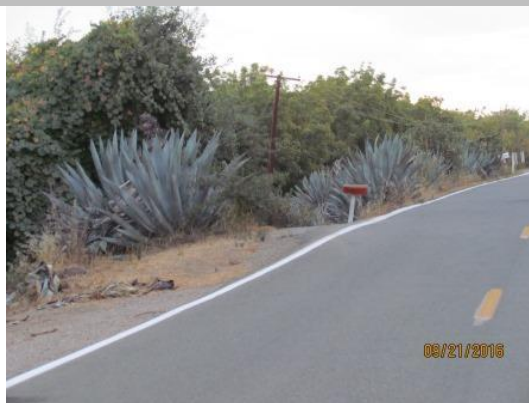
Photo 1 of 1 : SP_2017_RD1001_38_17_20170316_00010.jpg

LM Start	6.39	Rating **	U	Issue No.	17
LM End	6.46	Issue Type +	En	Location *	LS
Category	Earthen Levee			GPS Latitude/Longitude	
				Start	End
Item	Vegetation			38.866032 °	38.865195 °
				-121.619489 °	-121.620017 °
DWR ID	DWR_RD1001_04_s_2012_17				
Comment Code					
V6 : Landscaping					
Inspector Comment

View of landscaping on the landside shoulder and slope looking downstream. Fall 2016.

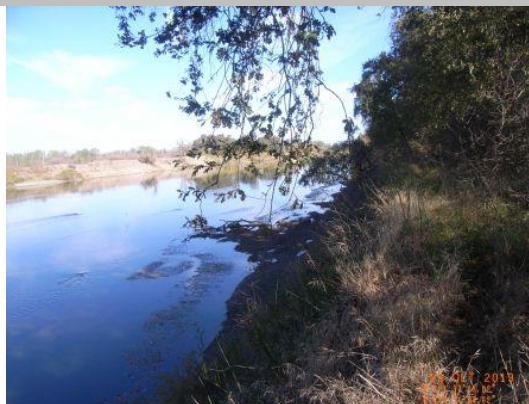
Photo 1 of 1 : SP_2017_RD1001_38_5_20170316_00005.jpg

LM Start	6.42	Rating **	M	Issue No.	5
LM End	6.51	Issue Type +	Ma	Location *	WS
Category	Supplemental			GPS Latitude/Longitude	
				Start	End
Item	2015 USACE Erosion Survey, DRAFT			38.865875 °	38.864706 °
				-121.619983 °	-121.620813 °
DWR ID	DWR_RD1001_04_s_2016_5				
Comment Code					
Inspector Comment					
2011 - Tall slumping sections. Scour around trees has exposed most of the roots. 2015: Recent large slope failure observed. [2015 Site ID: FHR_6-0_L]

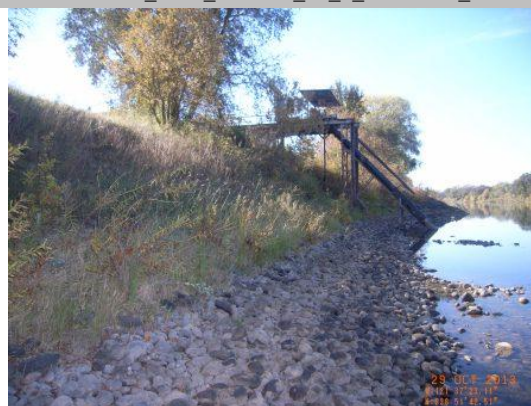
Photo 1 of 1 : SP_2017_RD1001_38_4_20170316_00004.jpg

LM Start	6.57	Rating **	M	Issue No.	4
LM End	6.77	Issue Type +	Ma	Location *	WS
Category	Supplemental			GPS Latitude/Longitude	
				Start	End
Item	2015 USACE Erosion Survey, DRAFT			38.863946 °	38.861558 °
				-121.621388 °	-121.623316 °
DWR ID	DWR_RD1001_04_s_2016_4				
Comment Code					
Inspector Comment					
2011 - Large slumped sections on the lower bank. 2012 - New cracks observed. 2015: No observed changes. [2015 Site ID: FHR_5-8_L]

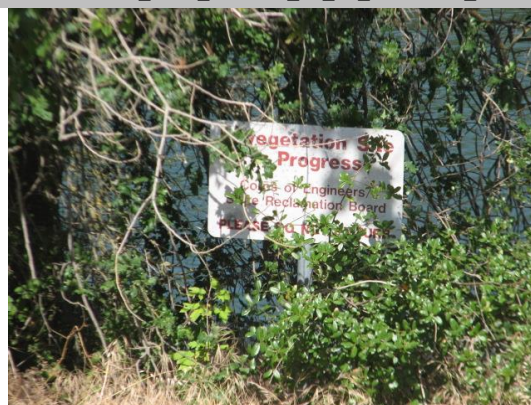
Photo 1 of 1 : SP_2017_RD1001_38_28_20170316_00017.jpg

LM Start	6.80	Rating **	A/W	Issue No.	28
LM End	6.80	Issue Type +	Ob	Location *	WS
Category	Earthen Levee			GPS Latitude/Longitude	
				Start	End
Item	Vegetation			38.861071 °	38.861071 °
				-121.623332 °	-121.623332 °
DWR ID	DWR_RD1001_04_s_2013_28				
Comment Code					
V8 : Environmental Requirements.					
Inspector Comment

Revegetation site. Spring 2013

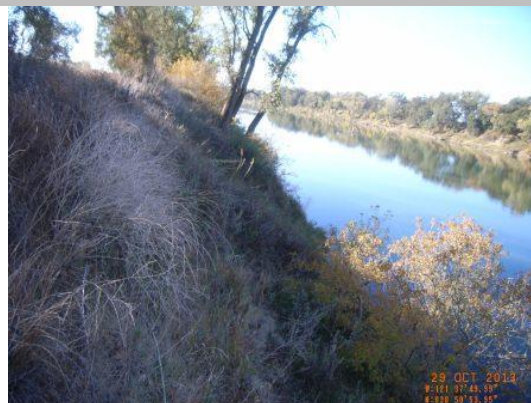
Photo 1 of 1 : SP_2017_RD1001_38_8_20170316_00008.jpg

LM Start	7.47	Rating **	M	Issue No.	8
LM End	7.79	Issue Type +	Ma	Location *	WS
Category	Supplemental			GPS Latitude/Longitude	
				Start	End
Item	2015 USACE Erosion Survey, DRAFT			38.852394 °	38.848004 °
				-121.629231 °	-121.630873 °
DWR ID	DWR_RD1001_04_s_2016_8				
Comment Code					
Inspector Comment					
2000 - Steep bank off berm with some slumps and fallen trees, continued erosion. 2002 - Site lengthened upstream and downstream due to vertical bank along most of the reach. 2010 - Site extended upstream. 2011 - Minimal new erosion. 2012 - Site extended on the upstream end, new tree pop-out, and bank erosion continues to worsen. 2013 - Minor new erosion at the toe and top of bank. 2015: No observed changes. [2015 Site ID: FHR_5-0_L]

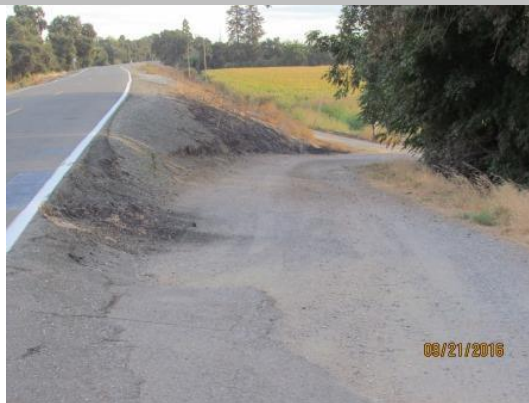
Photo 1 of 1 : SP_2017_RD1001_38_36_20170316_00023.jpg

LM Start	7.60	Rating **	A/W	Issue No.	36
LM End	7.60	Issue Type +	Ma	Location *	WS
Category	Earthen Levee			GPS Latitude/Longitude	
				Start	End
Item	Erosion / Bank Caving			38.850521 °	38.850521 °
				-121.629423 °	-121.629423 °
DWR ID	DWR_RD1001_04_f_2015_36				
Comment Code					
E2 : Schedule repair of erosion site prior to the next inspection.					
Inspector Comment					
Ramp has vertical cut into the levee prism.

View of vertical cut for ramp in the landside levee slope looking upstream. Fall 2016.

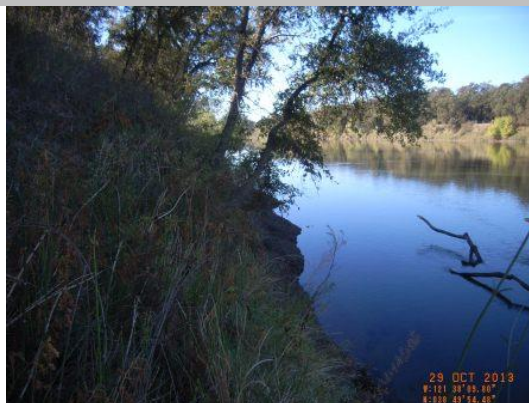
Photo 1 of 1 : SP_2017_RD1001_38_7_20170316_00007.jpg

LM Start	8.57	Rating **	M	Issue No.	7
LM End	8.97	Issue Type +	Ma	Location *	WS
Category	Supplemental			GPS Latitude/Longitude	
				Start	End
Item	2015 USACE Erosion Survey, DRAFT			38.836966 °	38.831498 °
				-121.634128 °	-121.636371 °
DWR ID	DWR_RD1001_04_s_2016_7				
Comment Code					
Inspector Comment					
2006 - Sandy, silty bank with intermittent pockets of erosion. Rotational failure and tree pop outs are most of the problem. Some upper slope fluvial erosion. 2010 - Site extended upstream. The lower Feather may benefit from a regional repair. 2011 - Site combined with 3.6. Minimal new erosion. 2013 - New erosion observed at bank toe. Trees on site now have exposed roots. 2015: No observed changes. [2015 Site ID: FHR_3-8_L]

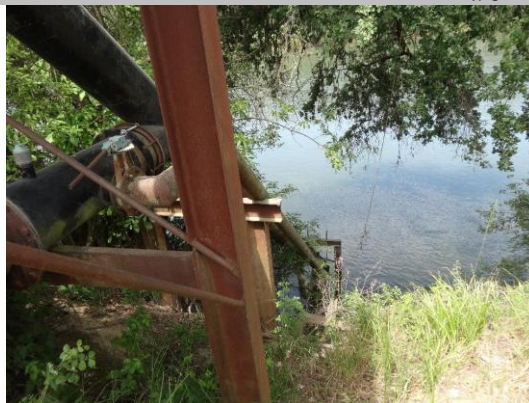
Photo 2 of 3 : UCIP_SP_2017_14563_24001.jpg

WS- inlet pipe and main pipe in pump station on river bank.

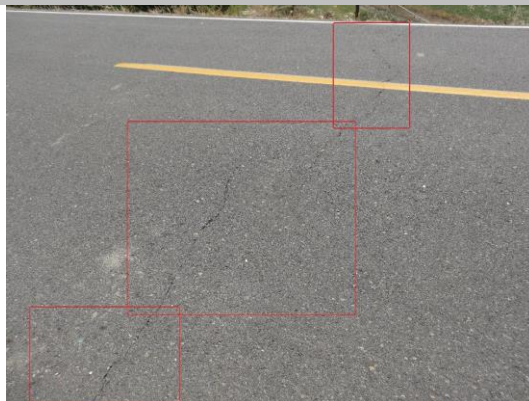
Photo 3 of 3 : UCIP_SP_2017_14563_24000.jpg

Levee Crown- road surface cracks along the pipe. Needs more investigation.

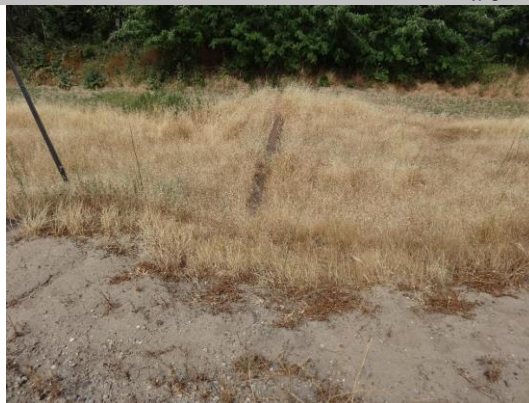
Photo 1 of 3 : UCIP_SP_2017_14544_23966.jpg

LM Start	9.44	Rating **	M	Issue No.	155
LM End	9.44	Issue Type +	En	Location *	LS
Category	Supplemental			GPS Latitude/Longitude	
				Start	End
Item	DWR UCIP Field Study			38.825107 °	38.825107 °
				-121.639369 °	-121.639369 °
DWR ID					
Comment Code					
Inspector Comment					
FS_ID:14544 DS_ID:22592 EP_NO: N/A Repair Type: Non-Urgent Crossing Status: Found UCIP Comments: - seems abandoned pipe crossing.- needs properly abandoned.- a 48" steel tank not found on landside. FIELD_STRUCT_DESC: 12-inch steel irrigation pipe through the levee, 5.0 feet below the crown, pump on the bank, pipe discharges into a 48-inch steel tank at the landward toe (Johnston) FS Date: 5/16/2013

WS- damaged pipe with holes, cracks on levee slope. River bank is not visible due to dense vegetation (top)

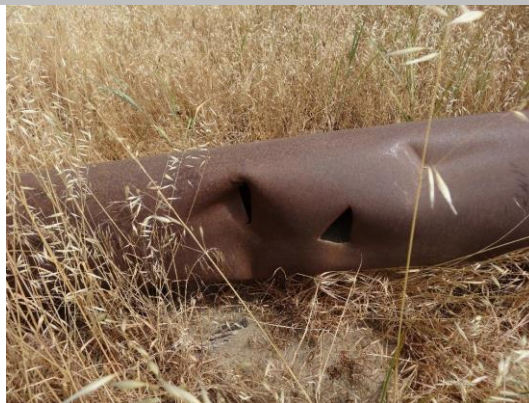
Photo 2 of 3 : UCIP_SP_2017_14544_23965.jpg

WS- abandoned damaged pipe with holes, cracks on levee slope.

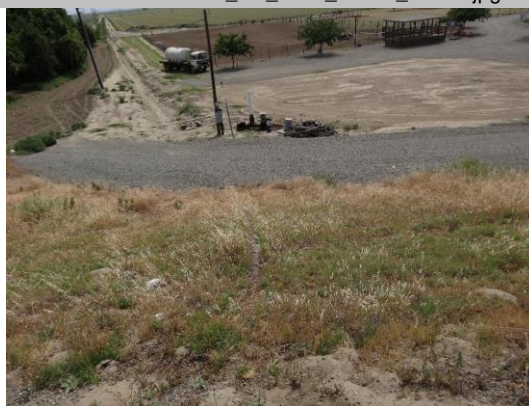
Photo 3 of 3 : UCIP_SP_2017_14544_23964.jpg

LM Start	9.44	Rating **	M	Issue No.	155 (cont)	
LM End	9.44	Issue Type +	En	Location *	LS	
Category	Supplemental			GPS Latitude/Longitude		
				Start	End	
Item	DWR UCIP Field Study			38.825107 °	38.825107 °	
				-121.639369 °	-121.639369 °	
DWR ID						
Comment Code						
Inspector Comment						
FS_ID:14544						
DS_ID:22592						
EP_NO: N/A						
Repair Type: Non-Urgent						
Crossing Status: Found						
UCIP Comments: - seems abandoned pipe crossing.- needs properly abandoned.- a 48" steel tank not found on landside.						
FIELD_STRUCT_DESC: 12-inch steel irrigation pipe through the levee, 5.0 feet below the crown, pump on the bank, pipe discharges into a 48-inch steel tank at the landward toe (Johnston)						
FS Date: 5/16/2013

LS- overview of landside, steel pipe on levee slope.

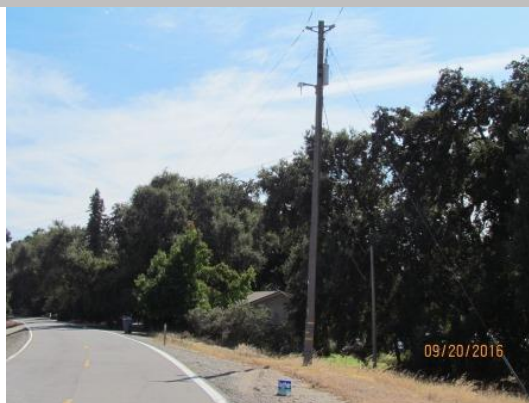
Photo 1 of 1 : SP_2017_RD1001_38_80_20170316_00044.jpg

LM Start	9.52	Rating **	M	Issue No.	80
LM End	9.52	Issue Type +	En	Location *	WS
Category	Earthen Levee			GPS Latitude/Longitude	
				Start	End
Item	Encroachments			38.823911 °	38.823911 °
				-121.639869 °	-121.639869 °
DWR ID	DWR_RD1001_04_s_2016_80				
Comment Code					
PO : Pole					
Inspector Comment

View of pole on waterside crown. Fall 2016.

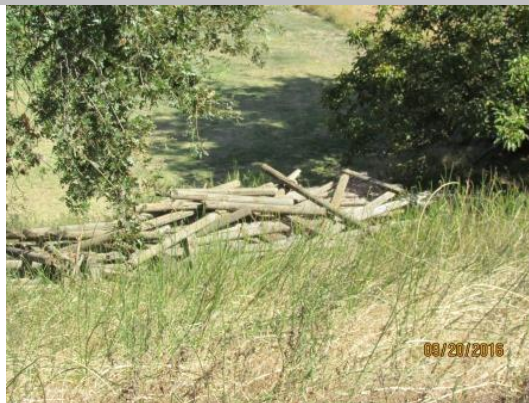
Photo 1 of 1 : SP_2017_RD1001_38_82_20170316_00045.jpg

LM Start	9.58	Rating **	M	Issue No.	82
LM End	9.58	Issue Type +	En	Location *	LS
Category	Earthen Levee			GPS Latitude/Longitude	
				Start	End
Item	Encroachments			38.823053 °	38.823053 °
				-121.639911 °	-121.639911 °
DWR ID	DWR_RD1001_04_s _ 2016_82				
Comment Code					
DE : Debris					
Inspector Comment					
Old fence post pile at landside levee toe.

View of a pile of fence post at the landside levee toe. Fall 2016.

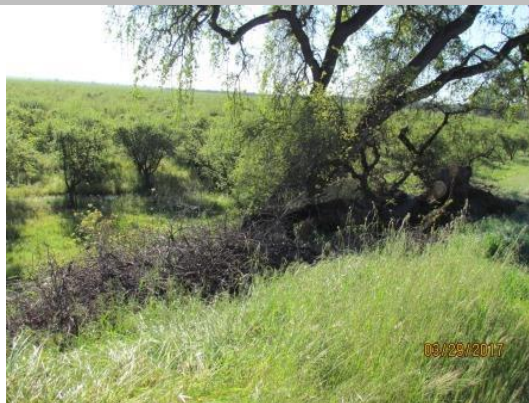
Photo 1 of 1 : SP_2017_RD1001_38_53_20170403_00080.jpg

View looking downstream at a downed tree and limbs, Spring 2017.

LM Start	9.81	Rating **	M	Issue No.	53
LM End	9.81	Issue Type +	Ma	Location *	LS
Category	Earthen Levee			GPS Latitude/Longitude	
				Start	End
Item	Encroachments			38.819784 °	38.819784 °
				-121.639555 °	-121.639555 °
DWR ID	DWR_RD1001_04_s _ 2017_53				
Comment Code					
TR : Tree or limb					
Inspector Comment					
Remove downed tree and limbs, Spring 2017.

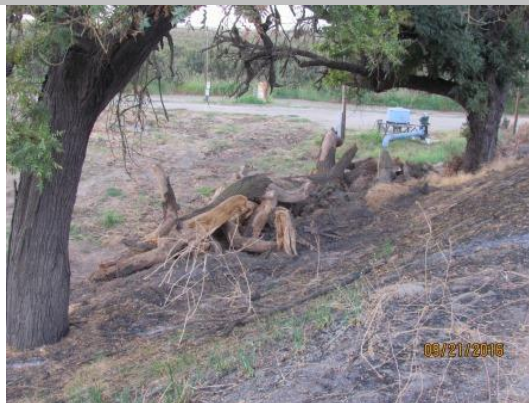
Photo 1 of 1 : SP_2017_RD1001_38_66_20170316_00039.jpg

LM Start	9.97	Rating **	M	Issue No.	66
LM End	9.97	Issue Type +	En	Location *	LS
Category	Earthen Levee			GPS Latitude/Longitude	
				Start	End
Item	Encroachments			38.817659 °	38.817659 °
				-121.638404 °	-121.638404 °
DWR ID	DWR_RD1001_04_f_ 2016_66				
Comment Code					
TR : Tree or limb					
Inspector Comment					
Downed tree pushed up to levee toe.

View of large tree pushed up to the landside levee toe. Fall 2016.

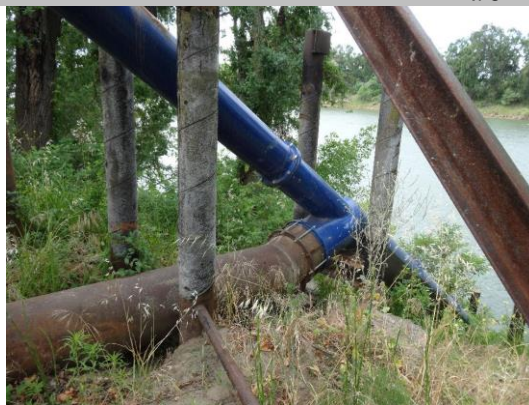
Photo 2 of 3 : UCIP_SP_2017_41723_23976.jpg

WS- main steel pipe on levee surface (without paint).

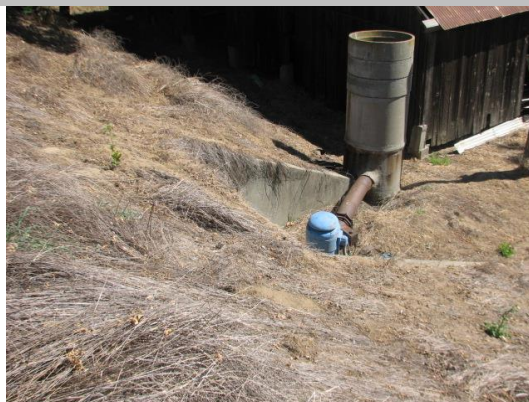
Photo 1 of 1 : SP_2017_RD1001_38_30_20170316_00019.jpg

LM Start	10.60	Rating **	M	Issue No.	30
LM End	10.60	Issue Type +	En	Location *	LS
Category	Earthen Levee			GPS Latitude/Longitude	
				Start	End
Item	Encroachments			38.809257 °	38.809257 °
				-121.633909 °	-121.633909 °
DWR ID	DWR_RD1001_04_s_2013_30				
Comment Code					
RW : Retaining Wall					
Inspector Comment

A retaining wall is within the profile of the slope. Spring 2013

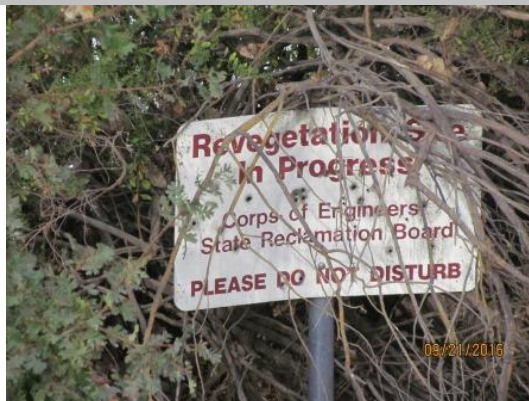
Photo 1 of 1 : SP_2017_RD1001_38_50_20170316_00029.jpg

LM Start	11.13	Rating **	A/W	Issue No.	50
LM End	11.13	Issue Type +	Ob	Location *	WS
Category	Earthen Levee			GPS Latitude/Longitude	
				Start	End
Item	Vegetation			38.801689 °	38.801689 °
				-121.632667 °	-121.632667 °
DWR ID	DWR_RD1001_04_s_2015_50				
Comment Code					
V8 : Environmental Requirements.					
Inspector Comment

Vegetation has been introduced in this area. Photo taken Fall 2016.

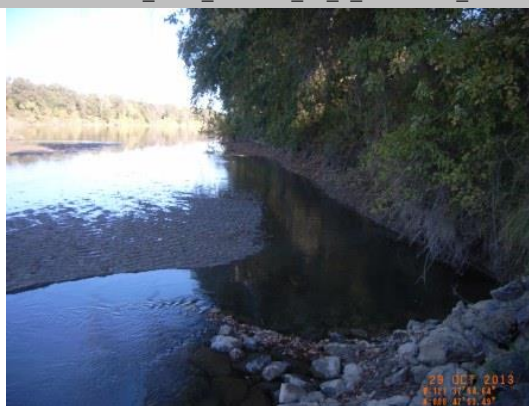
Photo 1 of 1 : SP_2017_RD1001_38_6_20170316_00006.jpg

LM Start	11.18	Rating **	M	Issue No.	6
LM End	11.37	Issue Type +	Ma	Location *	WS
Category	Supplemental			GPS Latitude/Longitude	
				Start	End
Item	2015 USACE Erosion Survey, DRAFT			38.800920 °	38.798165 °
				-121.633050 °	-121.631939 °
DWR ID	DWR_RD1001_04_s_2016_6				
Comment Code					
Inspector Comment					
2000 - Site is relatively stable except for some toe erosion at the upstream end, recommend monitoring the upstream end. 2004 - Some new block failures (10ft deep) at the toe of the upstream end. 2007 - Some minor new slumping at the waterline. 2013 - Minor new erosion along the bank toe. 2015: No observed changes. [2015 Site ID: FHR_1-0_L]

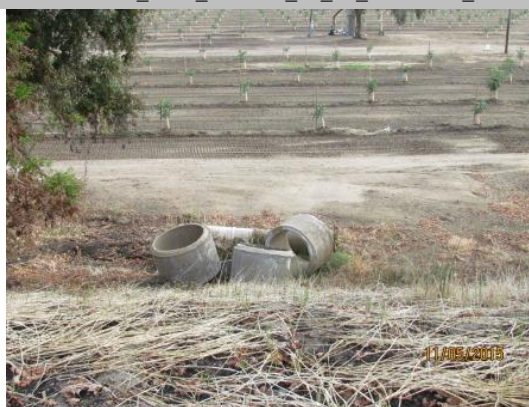
Photo 1 of 1 : SP_2017_RD1001_38_41_20170316_00026.jpg

LM Start	11.28	Rating **	M	Issue No.	41
LM End	11.28	Issue Type +	En	Location *	LS
Category	Earthen Levee			GPS Latitude/Longitude	
				Start	End
Item	Encroachments			38.799635 °	38.799635 °
				-121.631986 °	-121.631986 °
DWR ID	DWR_RD1001_04_f_2015_41				
Comment Code					
MA : Material					
Inspector Comment

View of the material at the landside levee toe.

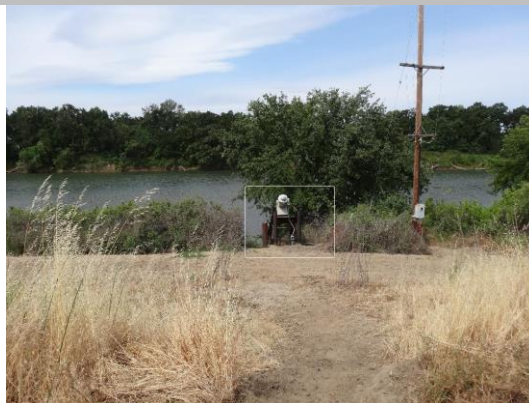
Photo 1 of 3 : UCIP_SP_2017_14548_23970.jpg

LM Start	11.28	Rating **	M	Issue No.	158
LM End	11.28	Issue Type +	En	Location *	LS
Category	Supplemental			GPS Latitude/Longitude	
				Start	End
Item	DWR UCIP Field Study			38.799561 °	38.799561 °
				-121.631964 °	-121.631964 °
DWR ID					
Comment Code					
Inspector Comment					
FS_ID:14548 DS_ID:22580 EP_NO: 3489 Repair Type: Non-Urgent Crossing Status: Found UCIP Comments: - siphon breaker on the landward shoulder not found.- cracked road surface along the pipe alienment. Needs more investigations. FIELD_STRUCT_DESC: 16-inch pipe through the levee, 3.0 feet below the crown, 40-horsepower slant pump mounted on a steel structure on the bank, pipe discharges into a 36-inch concrete standpipe on the landward toe (Permit No. 3489, 1960). FS Date: 5/16/2013

WS- slant pump on river bank.

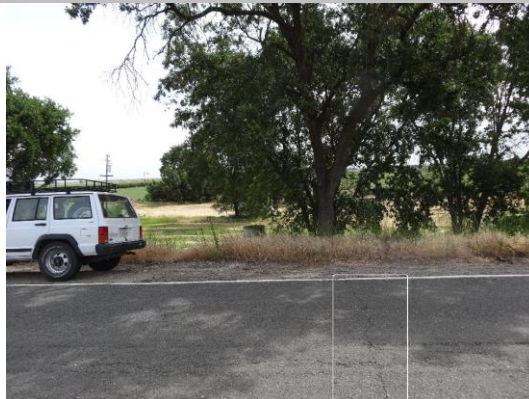
Photo 2 of 3 : UCIP_SP_2017_14548_23969.jpg

Levee Crown- surface crack along pipe crossing. Needs more investigation.

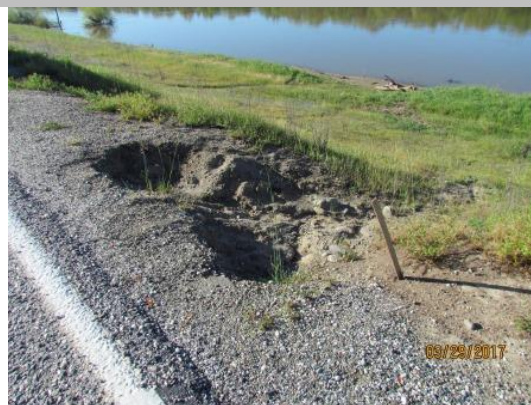
Photo 2 of 2 : SP_2017_RD1001_38_54_20170403_00079.jpg

View of vehicle ruts in levee shoulder that is getting worse due to erosion on the waterside looking downstream. Spring 2017.

LM Start	11.74	Rating **	M	Issue No.	54
LM End	11.74	Issue Type +	Ma	Location *	WS
Category	Earthen Levee			GPS Latitude/Longitude	
				Start	End
Item	Slope Stability			38.793796 °	38.793796 °
				-121.627829 °	-121.627829 °
DWR ID	DWR_RD1001_04_s_2015_54				
Comment Code					
S2 : Repair the levee slope damaged by foot traffic and prevent access where possible.					
Inspector Comment					
Vehicle ruts need to be repaired on the levee shoulder. Spring 2017.

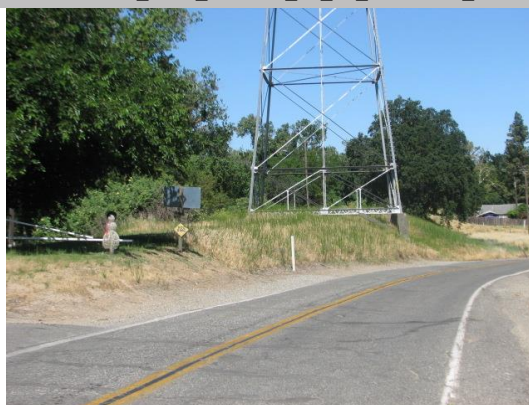
Photo 1 of 2 : SP_2017_RD1001_38_25_20170316_00014.jpg

LM Start	12.48	Rating **	U	Issue No.	25
LM End	12.48	Issue Type +	En	Location *	LS
Category	Earthen Levee			GPS Latitude/Longitude	
				Start	End
Item	Encroachments			38.786073 °	38.786073 °
				-121.618522 °	-121.618522 °
DWR ID	DWR_RD1001_04_s_2012_25				
Comment Code					
BU : Building					
Inspector Comment

A short section of the levee has limited access. Spring 2013

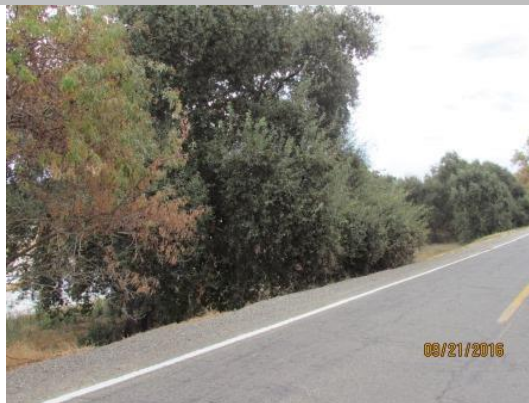
Photo 1 of 1 : SP_2017_RD1001_38_58_20170316_00032.jpg

View of landside tree that need the limbs trimmed up 5' above the slope for visibility and access. Fall 2016.

LM Start	13.12	Rating **	M	Issue No.	58
LM End	13.12	Issue Type +	Ma	Location *	LS
Category	Earthen Levee			GPS Latitude/Longitude	
				Start	End
Item	Trim / Thin Trees			38.782170 °	38.782170 °
				-121.607935 °	-121.607935 °
DWR ID	DWR_RD1001_04_f_2015_58				
Comment Code					
T1 : Trim trees to at least five feet above ground level.					
Inspector Comment					
Trim branch up 5' above slope. Fall 2016.

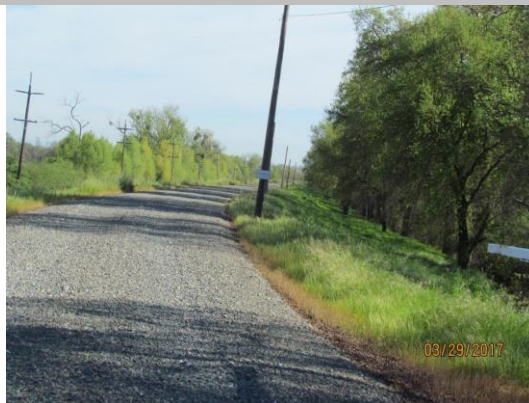
Photo 1 of 1 : SP_2017_RD1001_39_9_20170403_00019.jpg

View looking upstream of annual vegetation, Spring 2017.

LM Start	0.01	Rating **	M	Issue No.	9
LM End	5.38	Issue Type +	Ma	Location *	WS
Category	Earthen Levee			GPS Latitude/Longitude	
				Start	End
Item	Vegetation			38.781287 °	38.831062 °
				-121.605442 °	-121.529847 °
DWR ID	DWR_RD1001_05_s_2017_9				
Comment Code					
V1 : Control annual grass and weeds on the levee slopes and easements.					
Inspector Comment					
Maintain annual vegetation, Spring 2017.

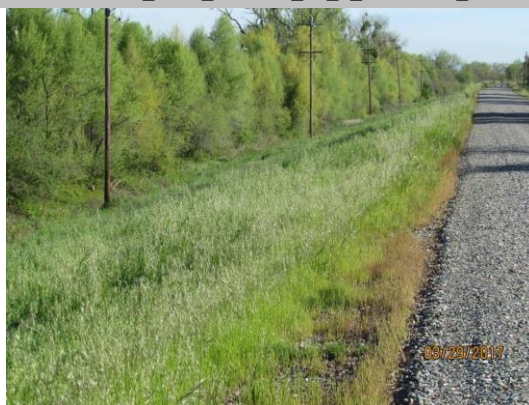
Photo 1 of 1 : SP_2017_RD1001_39_8_20170403_00020.jpg

LM Start	0.01	Rating **	M	Issue No.	8
LM End	5.38	Issue Type +	Ma	Location *	LS
Category	Earthen Levee			GPS Latitude/Longitude	
				Start	End
Item	Vegetation			38.781287 °	38.831062 °
				-121.605440 °	-121.529847 °
DWR ID	DWR_RD1001_05_s_2017_8				
Comment Code					
V1 : Control annual grass and weeds on the levee slopes and easements.					
Inspector Comment					
Maintain annual vegetation, Spring 2017.

View looking upstream of annual vegetation, Spring 2017.

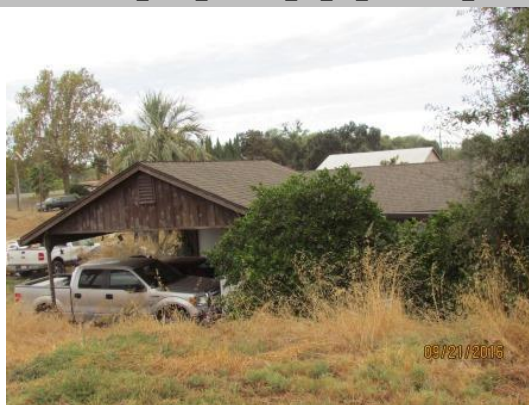
Photo 1 of 1 : SP_2017_RD1001_39_13_20170316_00005.jpg

LM Start	0.05	Rating **	M	Issue No.	13
LM End	0.05	Issue Type +	En	Location *	LS
Category	Earthen Levee			GPS Latitude/Longitude	
				Start	End
Item	Encroachments			38.781881 °	38.781881 °
				-121.605215 °	-121.605215 °
DWR ID	DWR_RD1001_05_f_2016_13				
Comment Code					
BU : Building					
Inspector Comment					
House and carport are at landside levee toe.

View of a house and carport that are at the levee toe. Fall 2016.

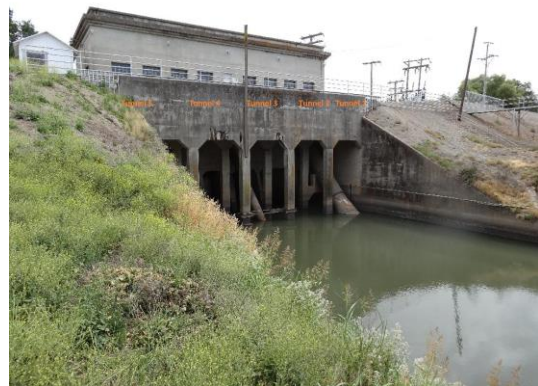
Photo 2 of 3 : UCIP_SP_2017_14393_23696.jpg

LS- Drainage structure with tunnels, pipes and pump house. Tunnel 1 at far right and tunnel 5 at far left. The pipe is located inside tunnel 3.

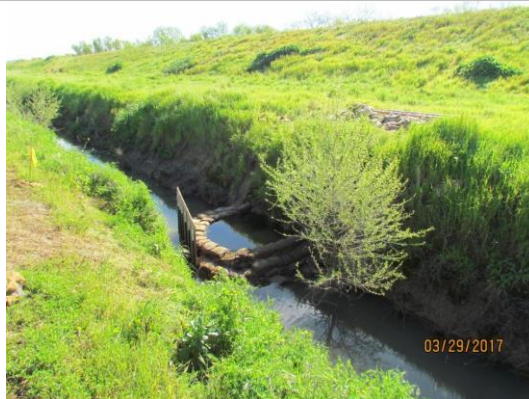
Photo 1 of 2 : SP_2017_RD1001_39_12_20170403_00021.jpg

LM Start	3.14	Rating **	U	Issue No.	12
LM End	3.14	Issue Type +	Ob	Location *	LS
Category	Earthen Levee			GPS Latitude/Longitude	
				Start	End
Item	Seepage / Sandboils			38.811580 °	38.811580 °
				-121.563050 °	-121.563050 °
DWR ID	DWR_RD1001_05_s_2017_12				
Comment Code					
Inspector Comment					
Boil in landside ditch. Sand bag ring was installed to flood fight, Spring 2017.

View looking upstream of a boil in landside ditch. Sand bag ring was installed to flood fight, Spring 2017.

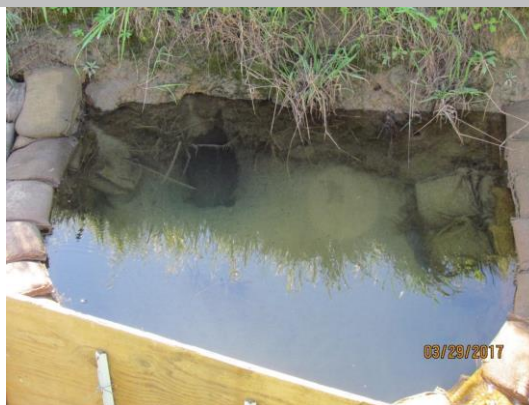
Photo 2 of 2 : SP_2017_RD1001_39_12_20170403_00023.jpg

View of a boil in landside ditch. Sand bag ring was installed to flood fight, Spring 2017.

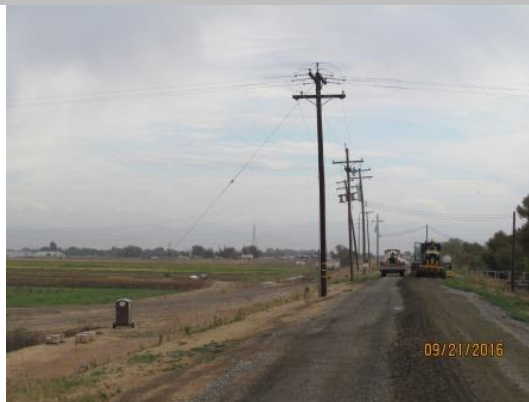
Photo 1 of 1 : SP_2017_RD1001_39_7_20170316_00003.jpg

LM Start	3.56	Rating **	M	Issue No.	7
LM End	3.81	Issue Type +	En	Location *	LS
Category	Earthen Levee			GPS Latitude/Longitude	
				Start	End
Item	Encroachments			38.814919 °	38.817178 °
				-121.556712 °	-121.552965 °
DWR ID	DWR_RD1001_05_s_2012_7				
Comment Code					
PO : Pole					
Inspector Comment

View of poles on the landside shoulder looking downstream. Fall 2016

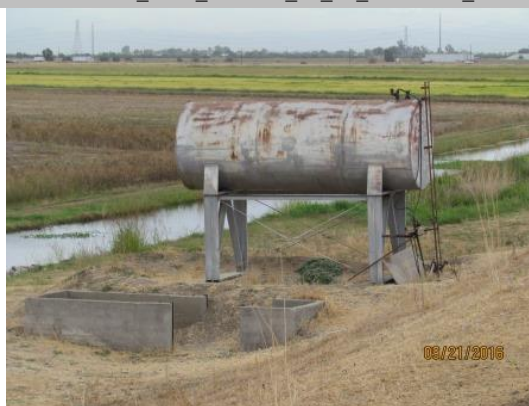
Photo 1 of 1 : SP_2017_RD1001_39_10_20170316_00004.jpg

LM Start	3.81	Rating **	M	Issue No.	10
LM End	3.81	Issue Type +	En	Location *	LS
Category	Earthen Levee			GPS Latitude/Longitude	
				Start	End
Item	Encroachments			38.817178 °	38.817178 °
				-121.552965 °	-121.552965 °
DWR ID	DWR_RD1001_05_s_2012_10				
Comment Code					
TA : Tank					
Inspector Comment					
Fuel tank at landside levee toe.

View of fuel tank at landside levee toe. Fall 2016.

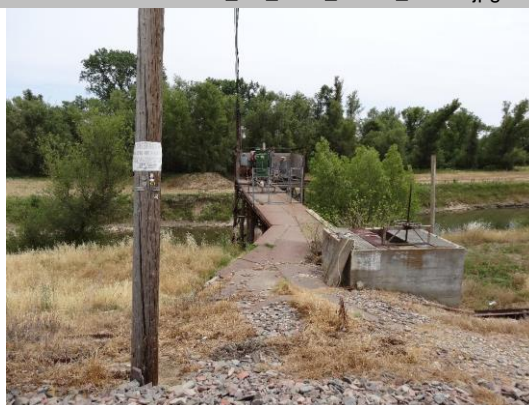
Photo 1 of 3 : UCIP_SP_2017_14486_23913.jpg

Comment Code					
Inspector Comment					
FS_ID:14486 DS_ID:22604 EP_NO: 1896 Repair Type: Non-Urgent Crossing Status: Found UCIP Comments: - slide gate in concrete box on waterside levee toe.- cracked headwall on landside- working during field survey- abandoned steel pipe, may need to remove it or properly adandoned. FIELD_STRUCT_DESC: 3 of 3: Abandoned 20-inch pipe of three pipes, a 30-inch and two 20-inch corrugated-metal asbestos-bonded pipe through the levee, 2.13 feet below the crown, three vertical pumps on a wooden piling structure in the stream, walkway to the pumps, slide gate in a concrete box on the waterward side (Permit No. 1896) FS Date: 5/15/2013

WS- pump station, walkway, and slide gate in concrete box.

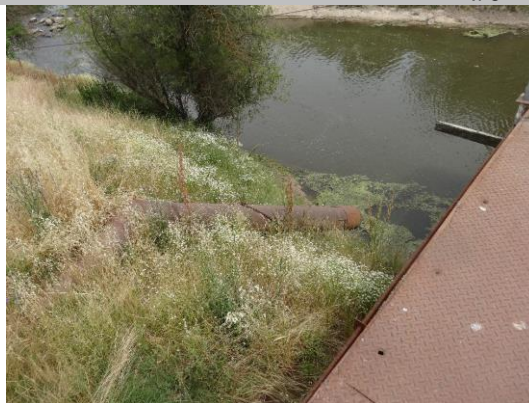
Photo 2 of 3 : UCIP_SP_2017_14486_23912.jpg

Comment Code						
Inspector Comment						
FS_ID:14486						
DS_ID:22604						
EP_NO: 1896						
Repair Type: Non-Urgent						
Crossing Status: Found						
UCIP Comments: - slide gate in concrete box on waterside levee toe.-						
cracked headwall on landside- working during field survey-						
abandoned steel pipe, may need to remove it or properly adandoned.						
FIELD_STRUCT_DESC: 3 of 3: Abandoned 20-inch pipe of three pipes,						
a 30-inch and two 20-inch corrugated-metal asbestos-bonded pipe						
through the levee, 2.13 feet below the crown, three vertical pumps on a						
wooden piling structure in the stream, walkway to the pumps, slide gate						
in a concrete box on the waterward side (Permit No. 1896)						
FS Date: 5/15/2013

WS- abandoned pipe adjacent to pump station on stream bank.

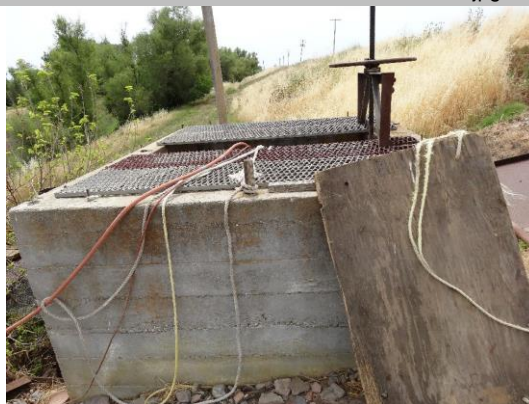
Photo 3 of 3 : UCIP_SP_2017_14486_23911.jpg

WS- slide gate in concrete box on levee toe.

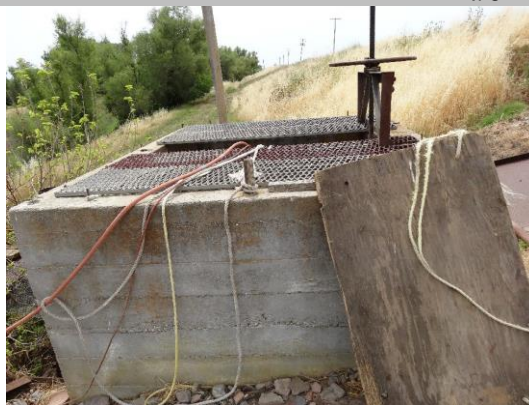
Photo 2 of 3 : UCIP_SP_2017_14484_23898.jpg

WS- slide gate in concrete box on levee toe.

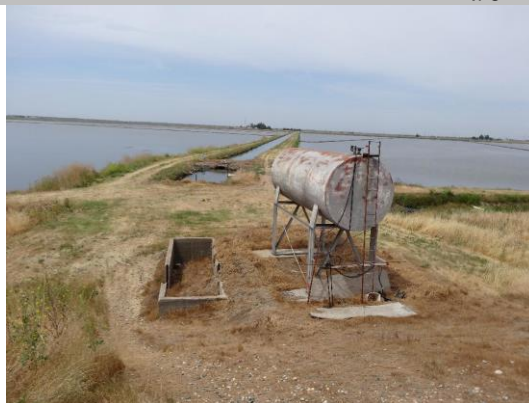
Photo 3 of 3 : UCIP_SP_2017_14484_23897.jpg

LM Start	3.81	Rating **	M	Issue No.	19 (cont)
LM End	3.81	Issue Type +	En	Location *	LS
Category	Supplemental			GPS Latitude/Longitude	
				Start	End
Item	DWR UCIP Field Study			38.817175 °	38.817175 °
				-121.552946 °	-121.552946 °
DWR ID					
Comment Code					
Inspector Comment					
FS_ID:14484 DS_ID:22595 EP_NO: 1896 Repair Type: Non-Urgent Crossing Status: Found UCIP Comments: - slide gate in concrete box on waterside levee toe.- cracked headwall on landside- working during field survey FIELD_STRUCT_DESC: 1 of 3: A 20-inch steel pipe of three pipes (a 30-inch and two 20-inch corrugated-metal asbestos-bonded pipe) through the levee, 2.13 feet below the crown, three vertical pumps on a wooden piling structure in the stream, walkway to the pumps, slide gate in a concrete box on the waterward side (Permit No. 1896) FS Date: 5/15/2013

LS- overview of irrigation ditch on levee toe (top)
